**SUBJECT: START 3, EPA Region 8, Contract No. EP-W-05-050, TDD No. 1008-13
Trip Report, Upper Animas Mining District, Silverton, San Juan County, Colorado**

TRIP REPORT
Upper Animas Mining District
Silverton, San Juan County, Colorado

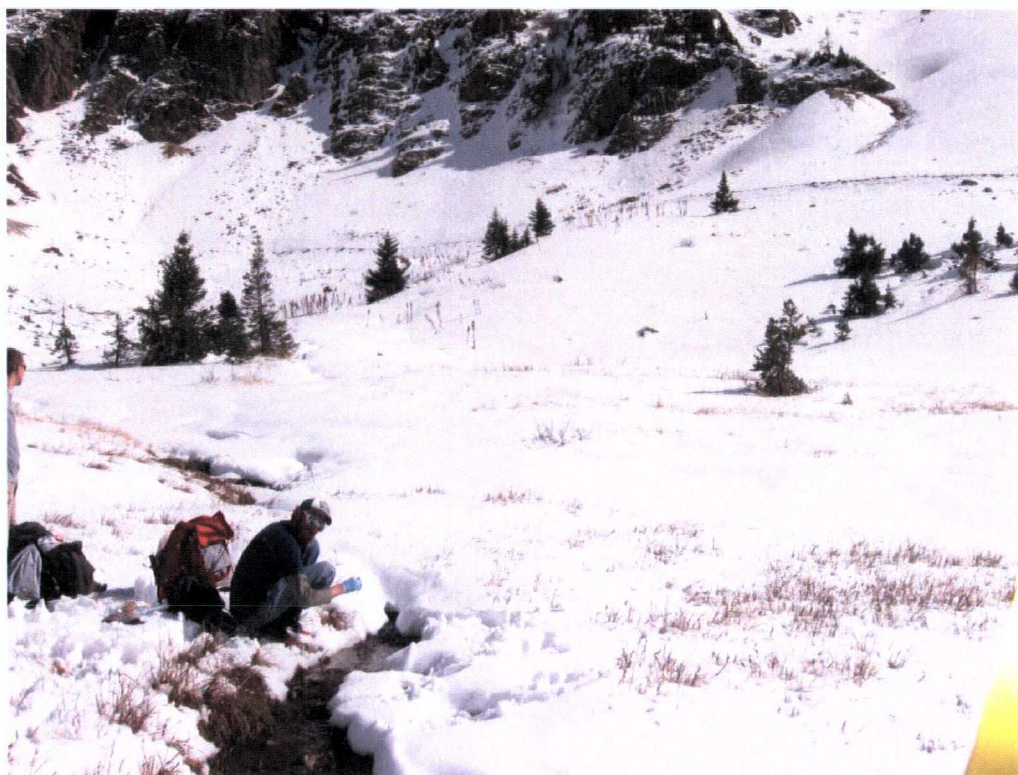
Photo 41

Location of UASW017 and UASE017 (Cement Creek downstream of Mogul Mine wetland).

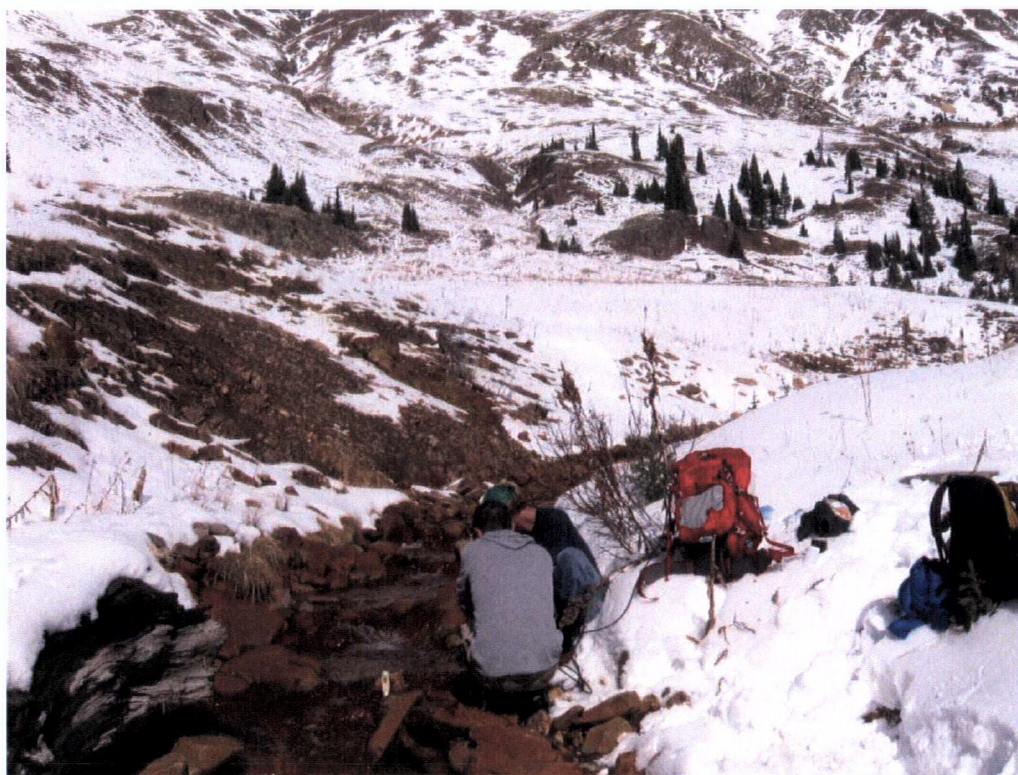
Photo 42

Collection of UASW019 and UASE019 (flow through Mogul Mine wetland).

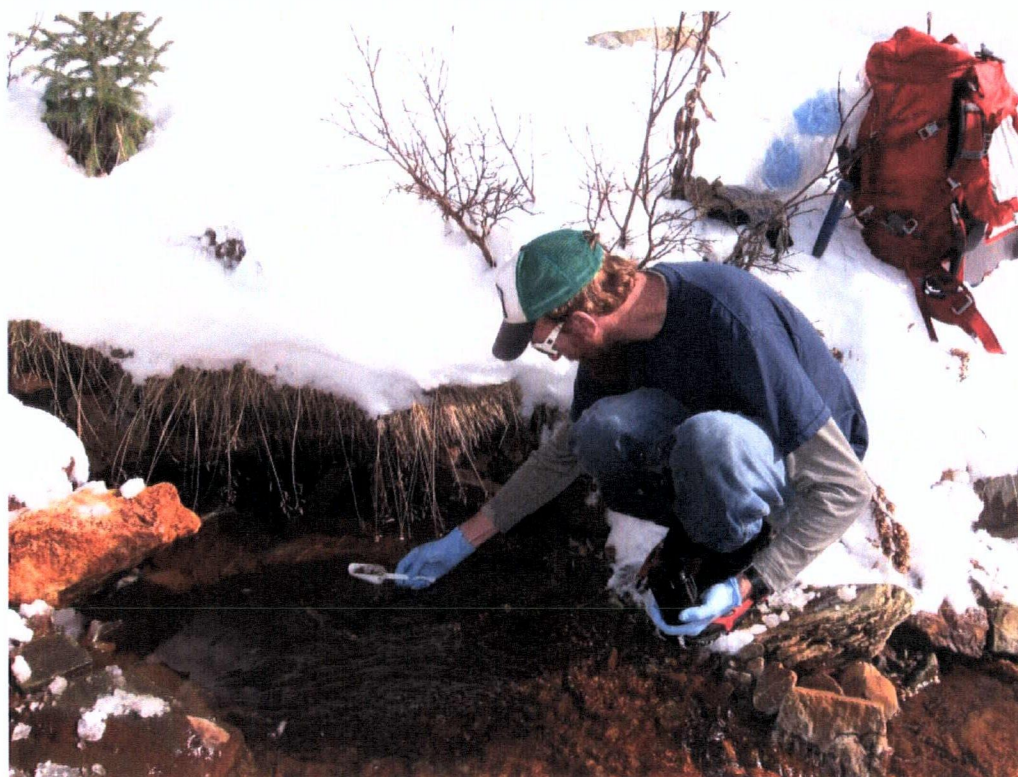
Photo 43

Collection of UASW018 and UASE018 (Cement Creek upstream of Mogul Mine wetland).

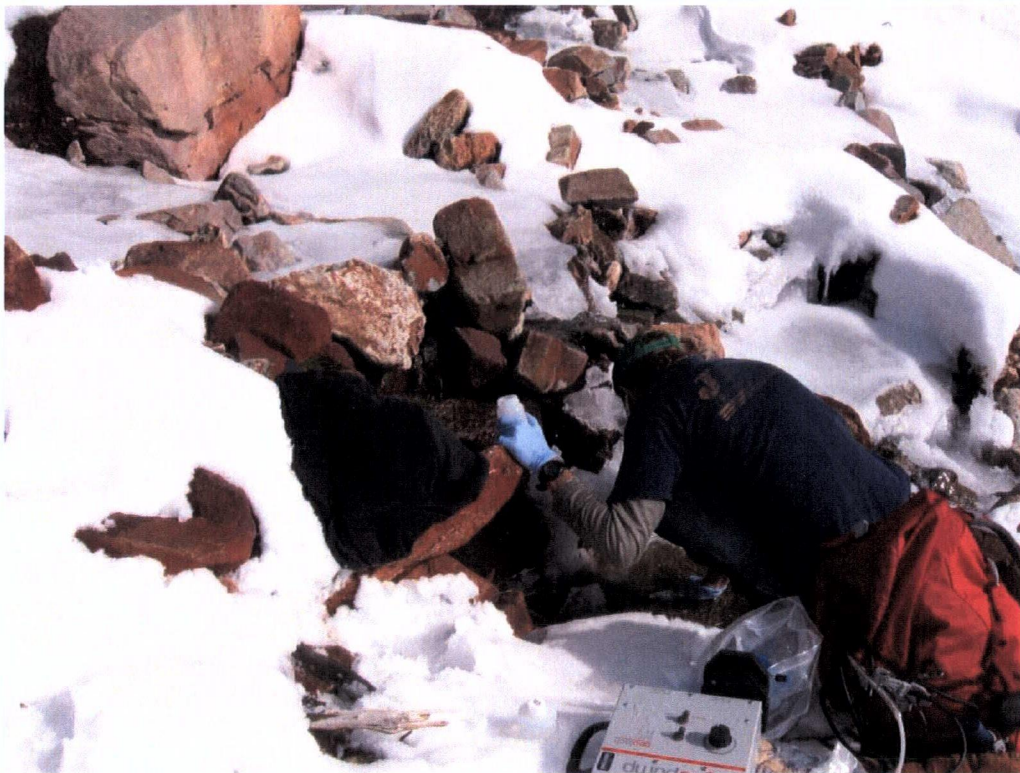
Photo 44

Collection of UASW018 and UASE018 (Cement Creek upstream of Mogul Mine wetland).

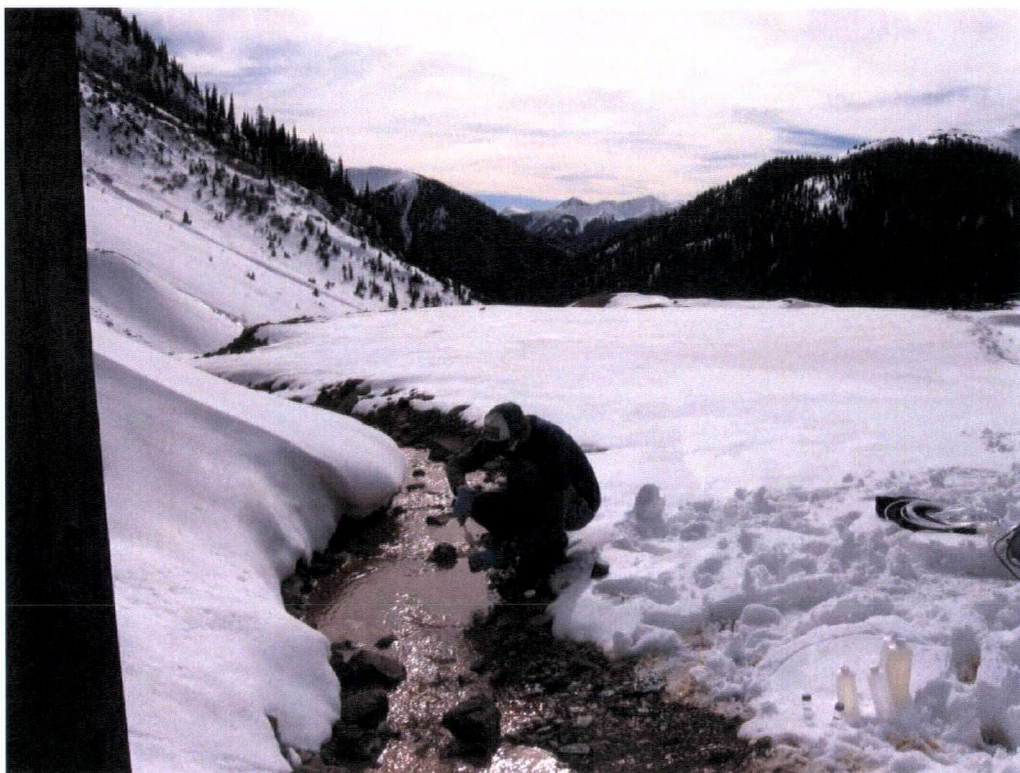
Photo 45
Collection of UASW020 and UASE020 (Cement Creek upstream of Mogul Mine).

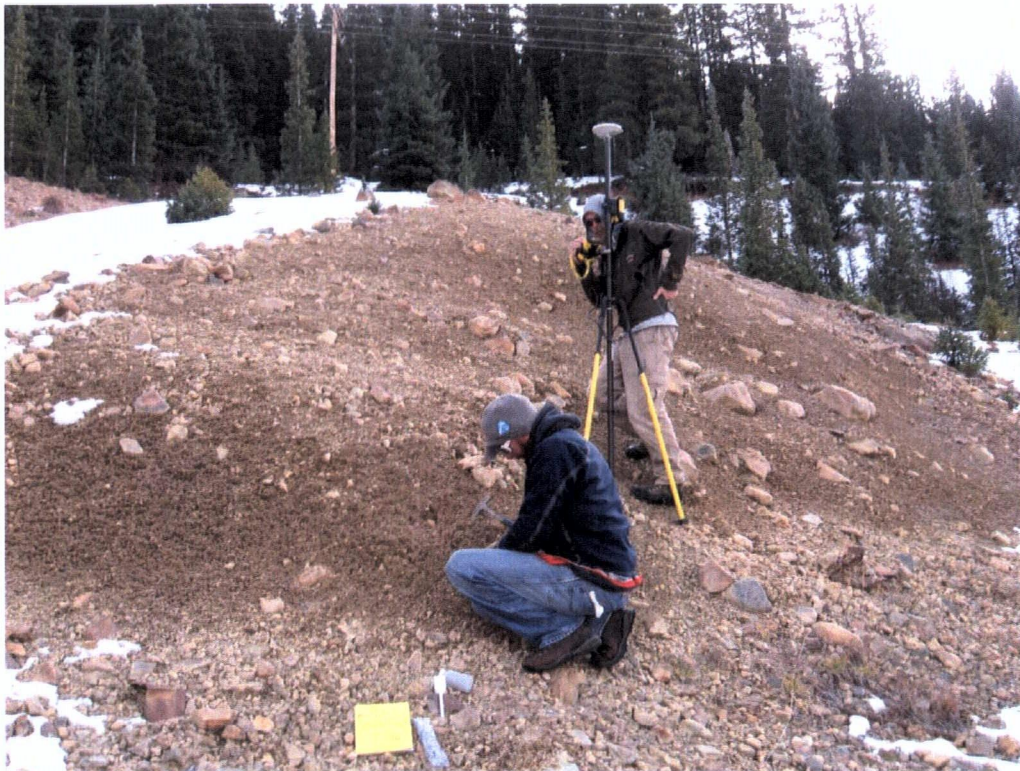
Photo 46
Collection of UAAD004 (Mogul Mine adit discharge).

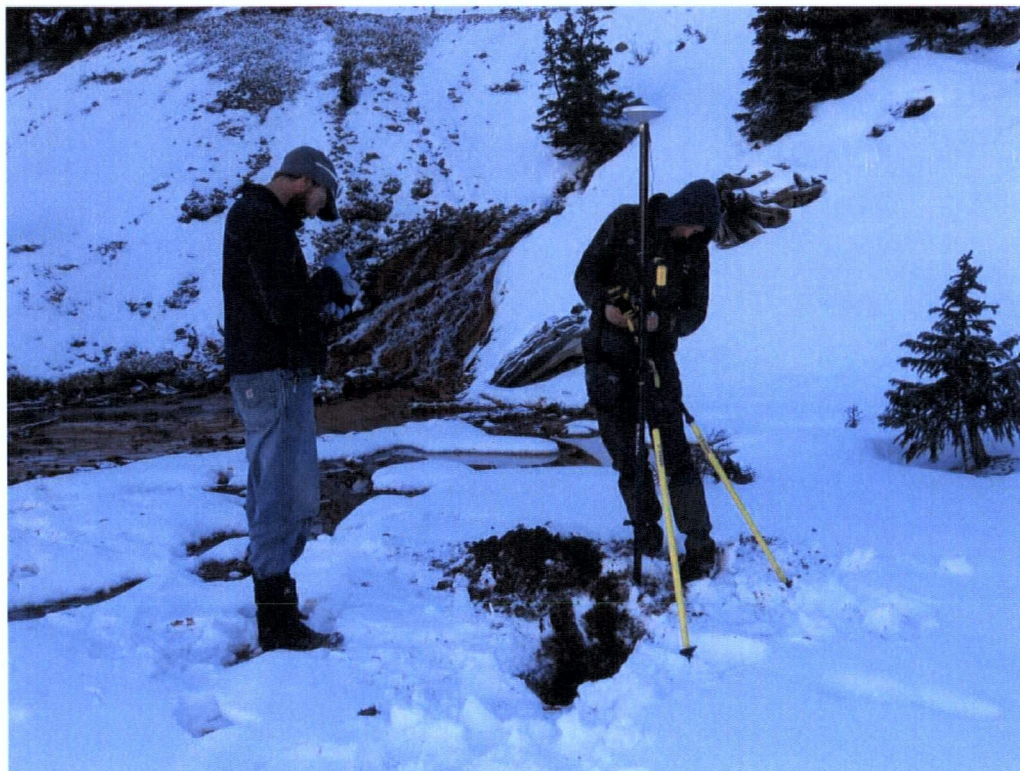
Photo 47
Collection of UASO002 (American Tunnel).

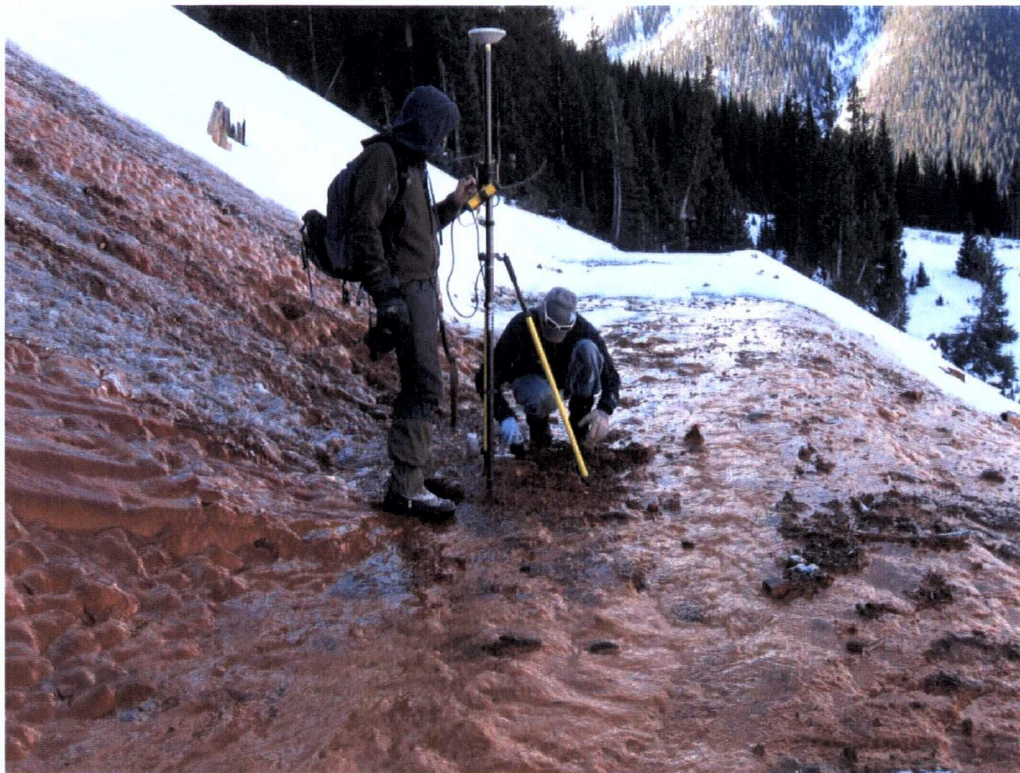
Photo 48
Collection of UASO003 (top pile at Red and Bonita).

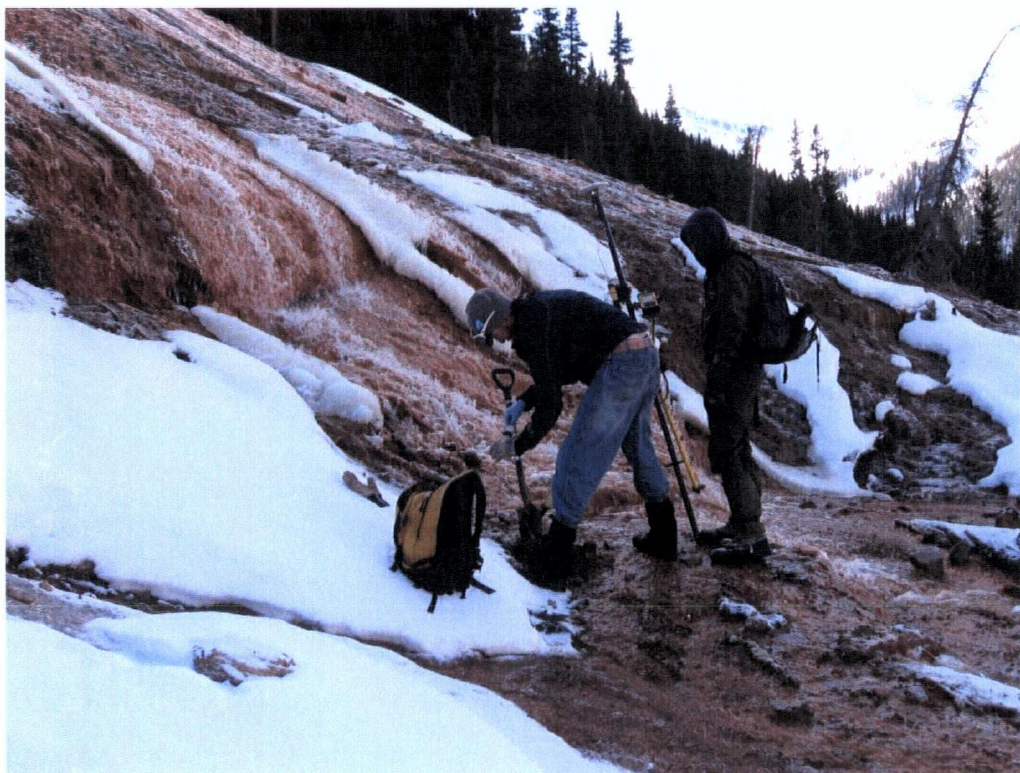
Photo 49
Collection of UASO004 (middle pile at Red and Bonita).

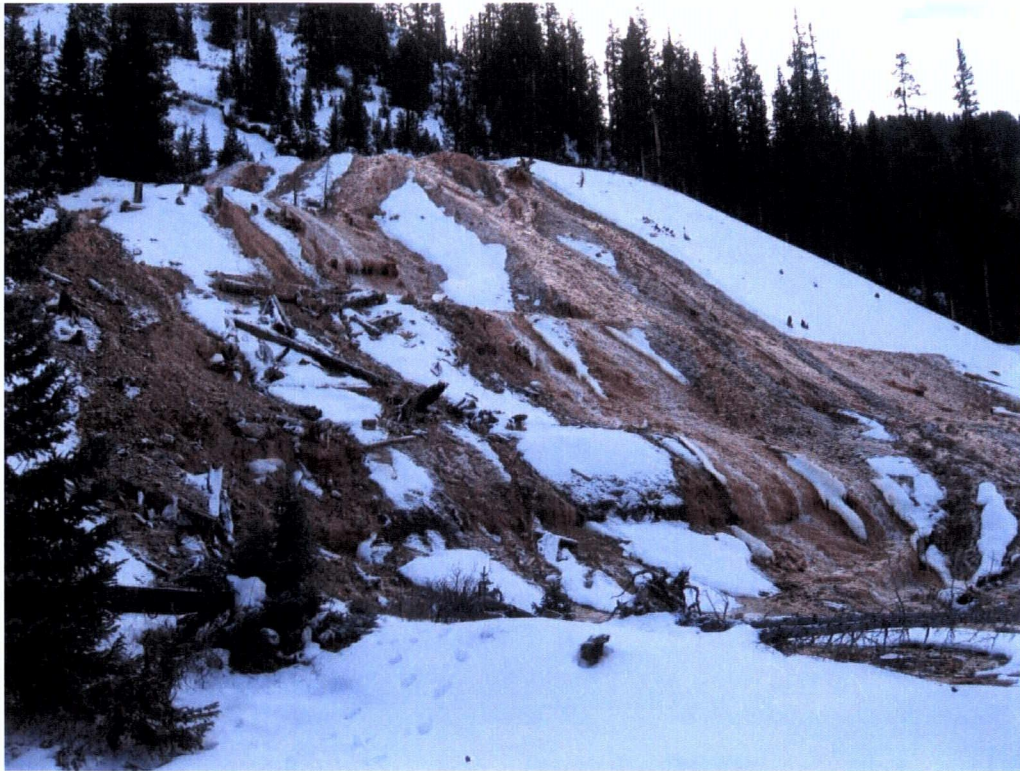
Photo 50
Collection of UASO005 (bottom pile at Red and Bonita).

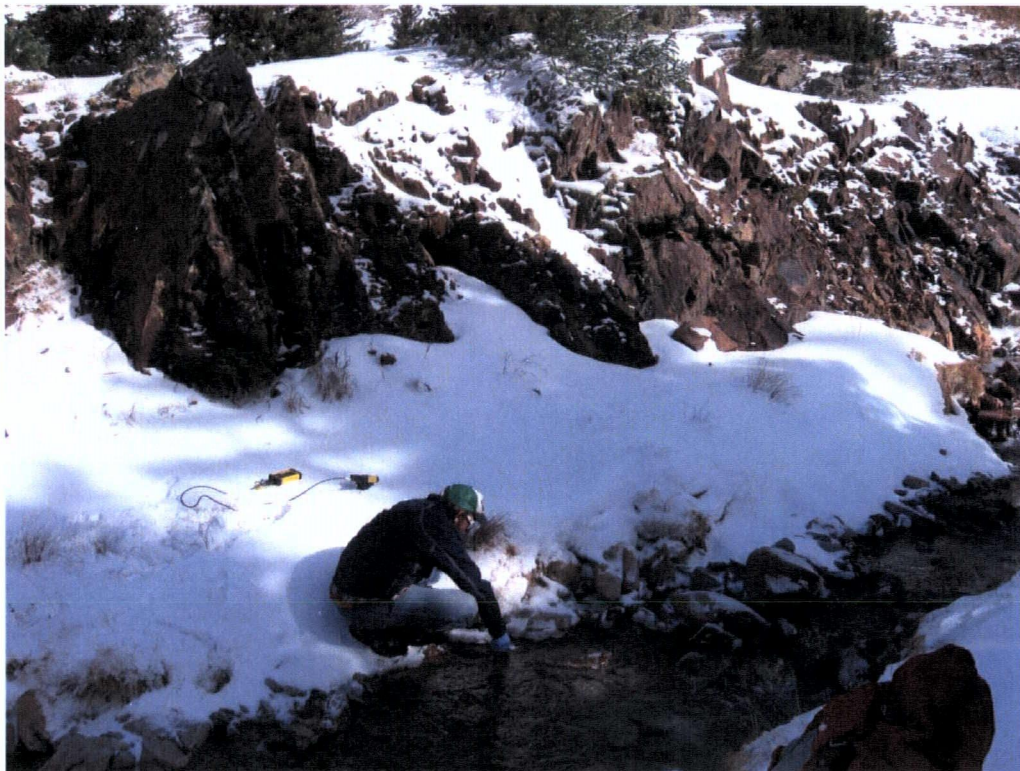
Photo 51
Red and Bonita waste piles.

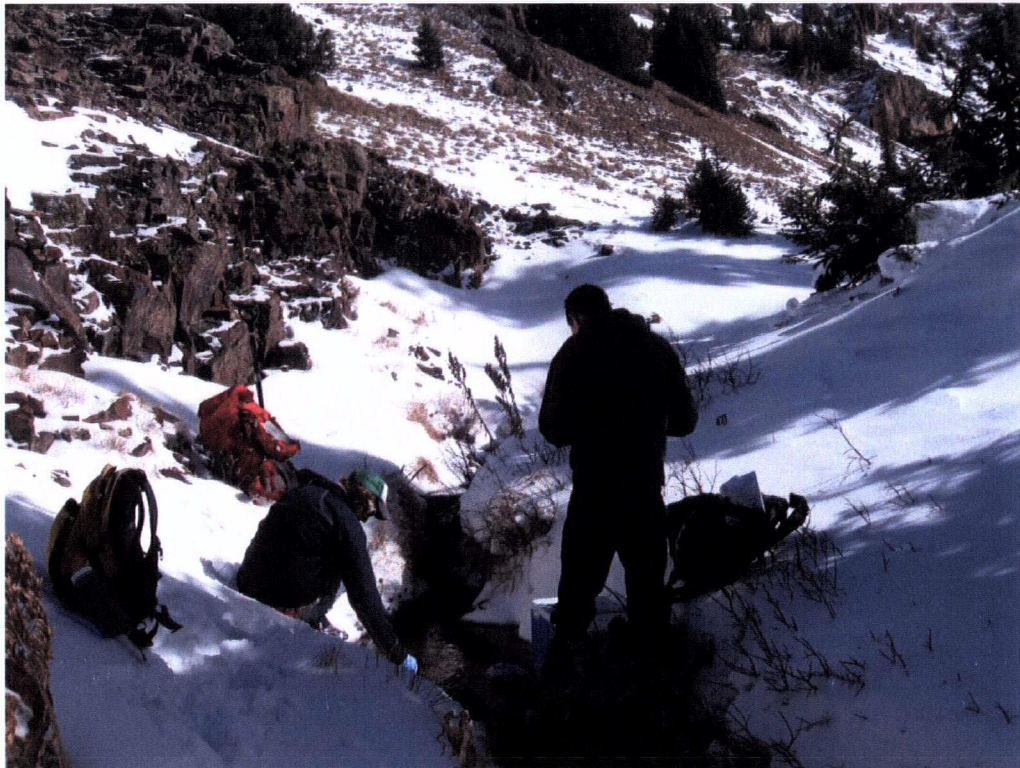
Photo 52
Collection of UASW021 and UASE021 (Cement Creek downstream of Mogul North Mine).

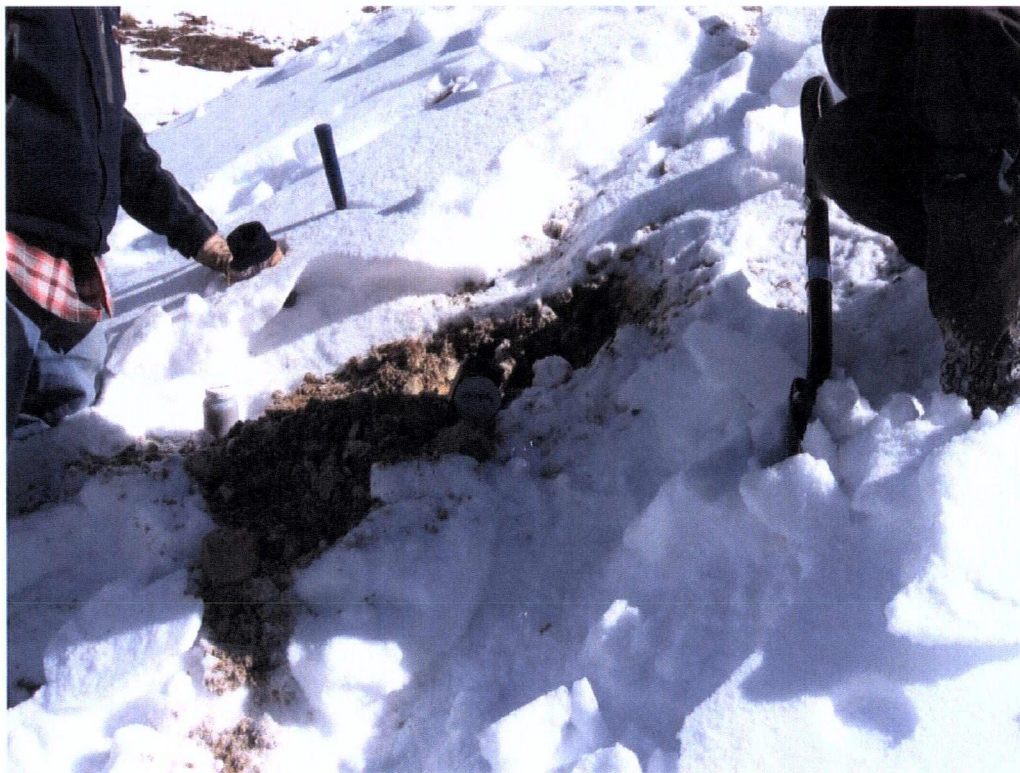
Photo 53
Collection of UASW022 and UASE022 (drainage from of Mogul North Mine).

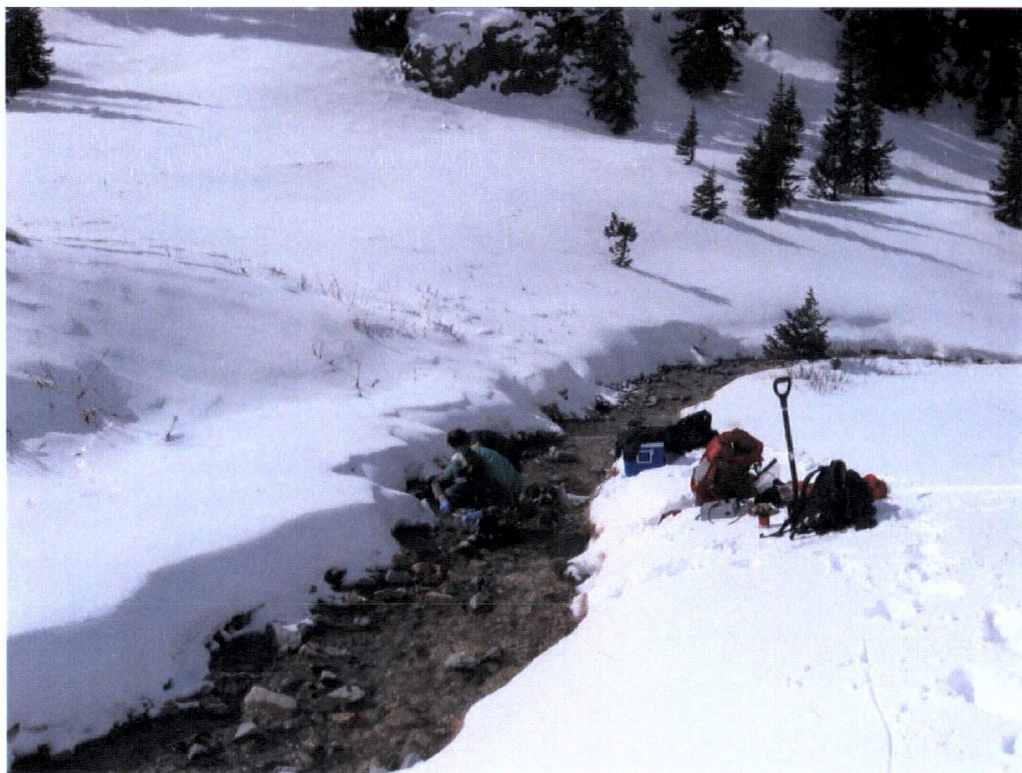
Photo 55
Seepage from the toe of the Mogul North waste pile.

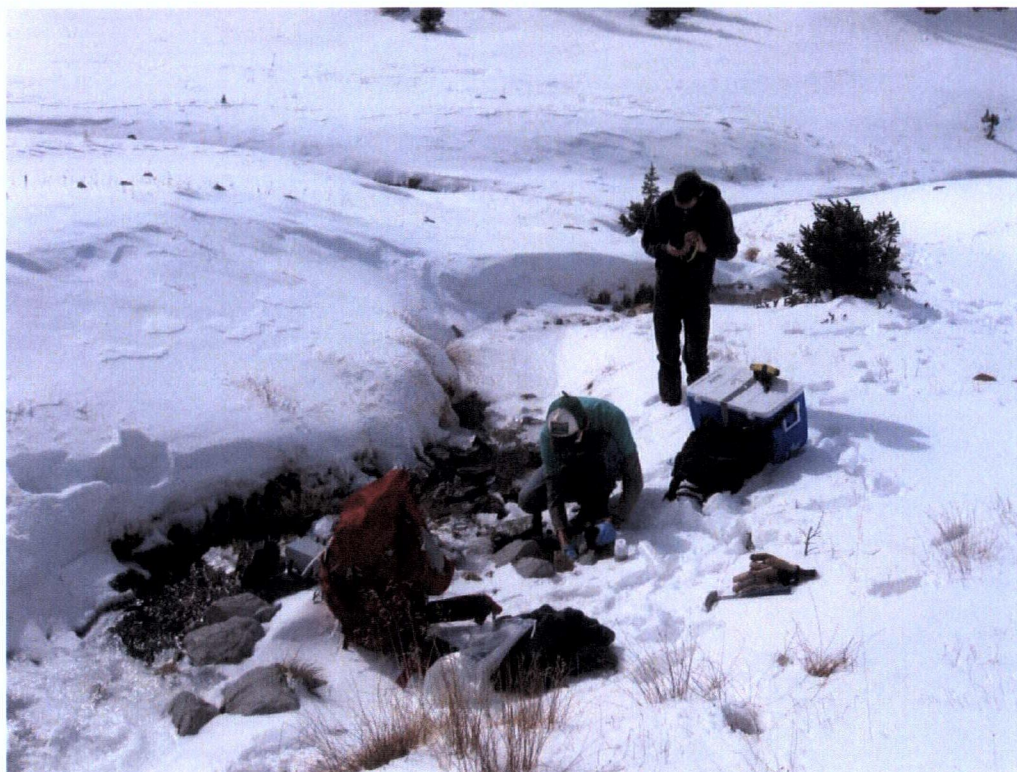
Photo 56
Collection of UASW023 and UASE023 (Cement Creek upstream of Queen Anne Mine).

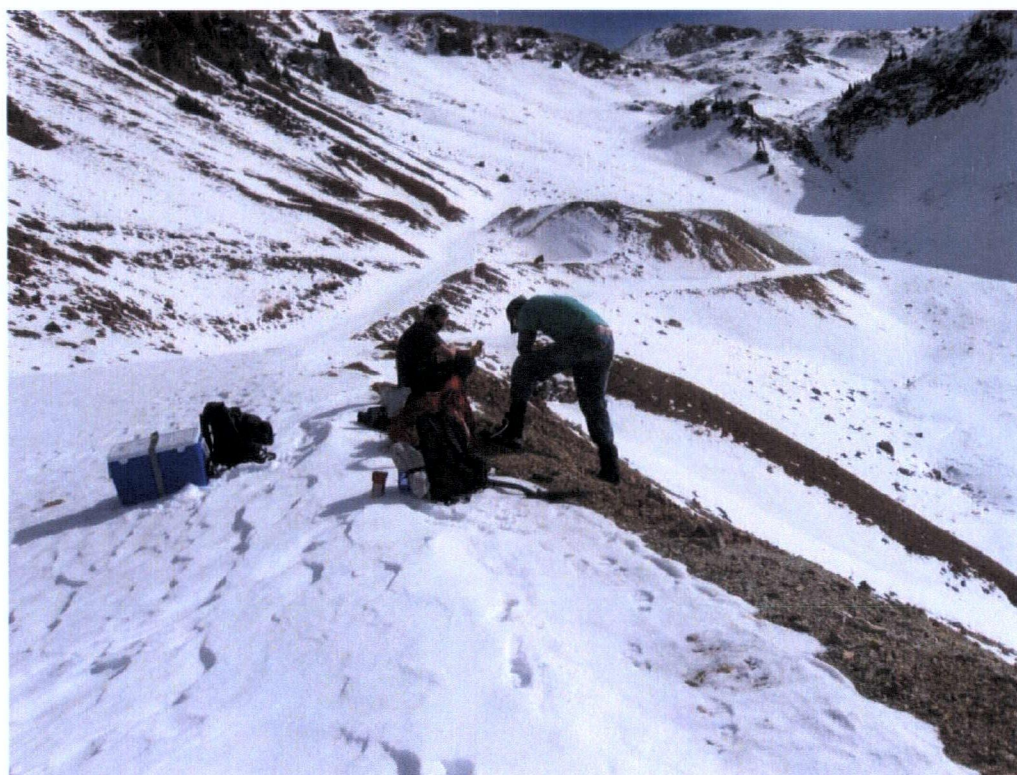
Photo 57
Collection of UASW024 and UASE024 (drainage from Queen Anne Mine).

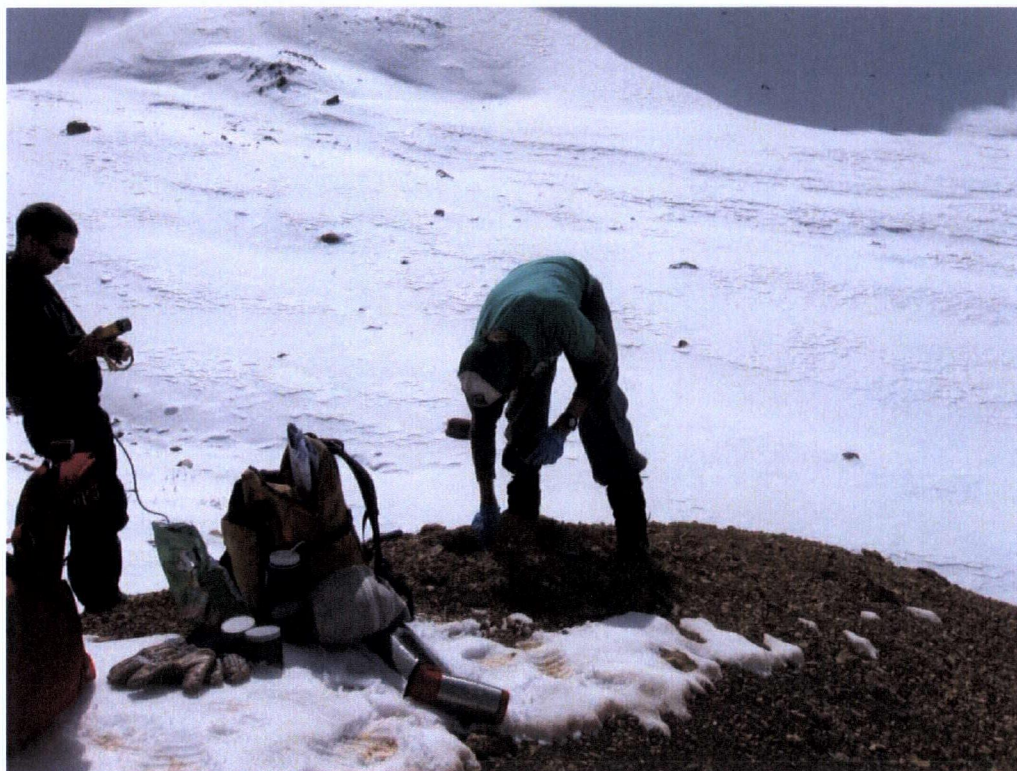
Photo 58
Collection of UASO007 (Grand Mogul Mine stope – west side).

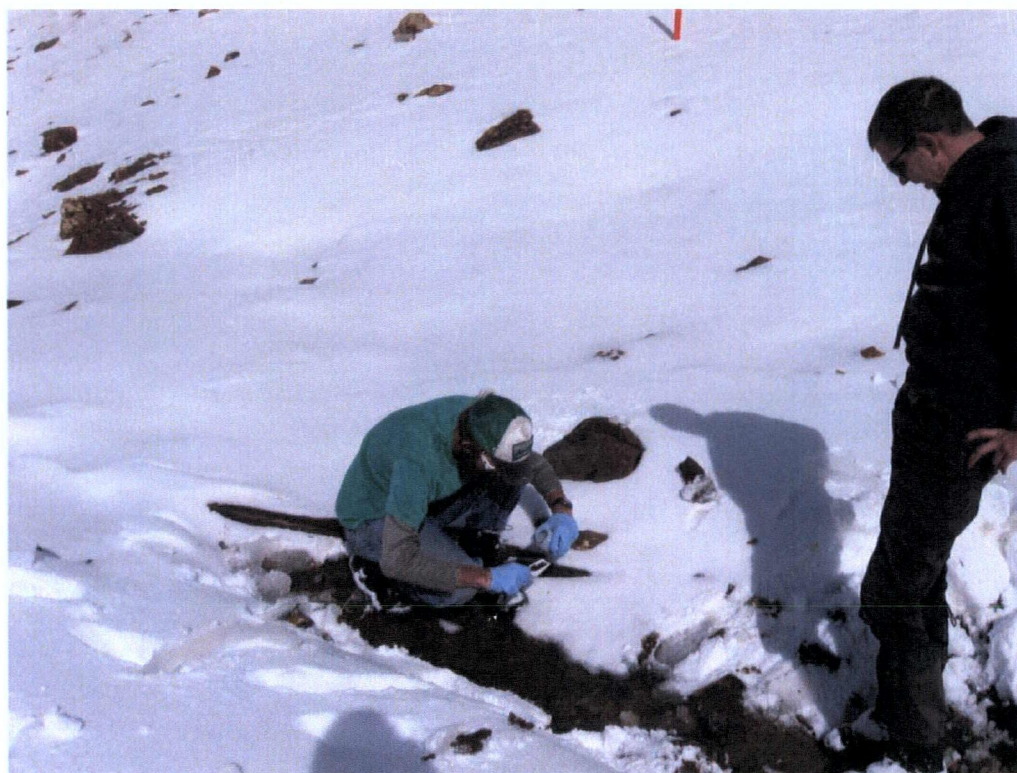
Photo 59
Collection of UASO008 (Grand Mogul Mine stope – east side).

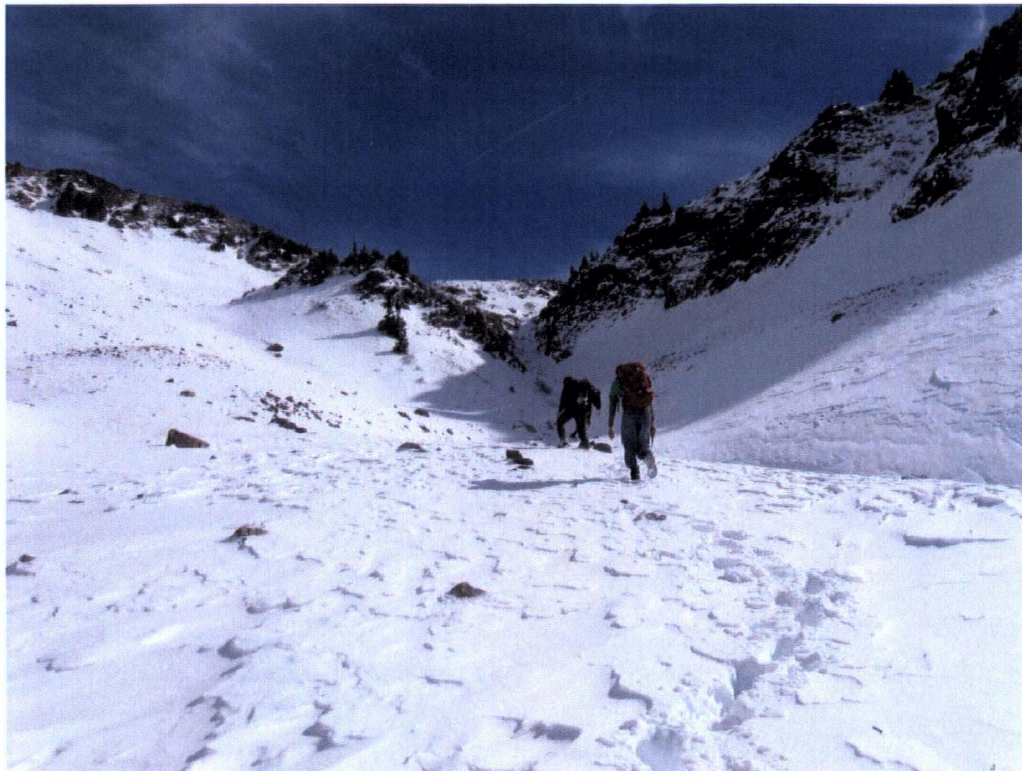
Photo 60
Collection of UASW059 and UASE059 (drainage from Grand Mogul Mine).

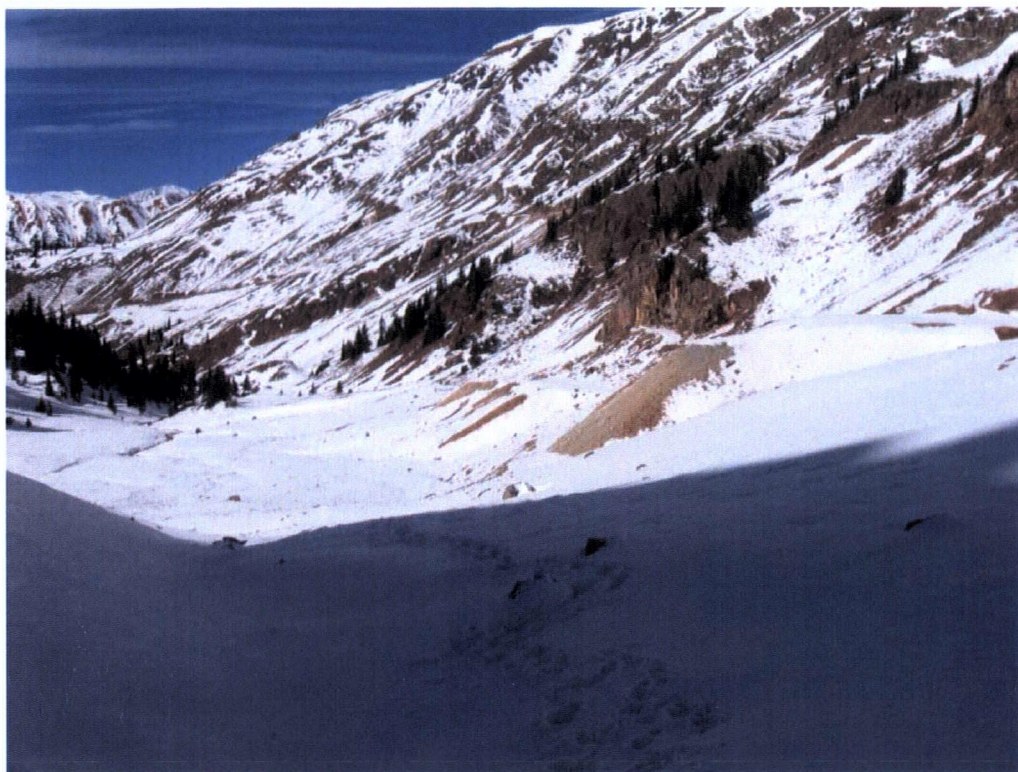
Photo 62
Collection of UASW030 and UASE030 (Cement Creek upstream of Grand Mogul Mine).

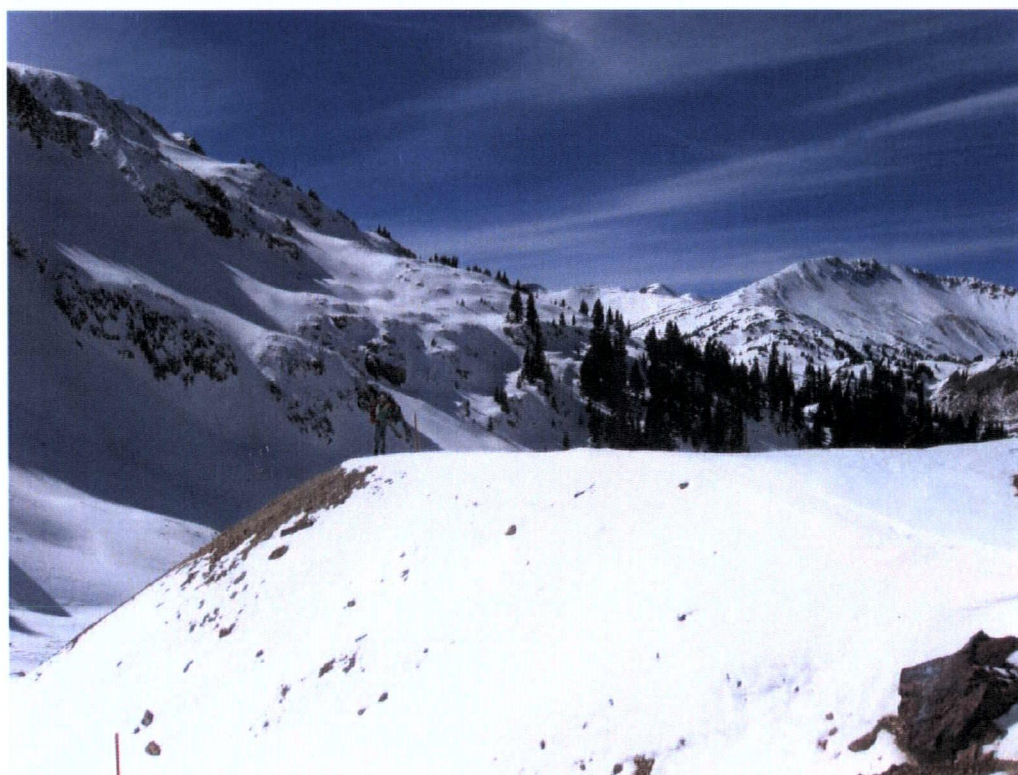
Photo 63
Grand Mogul Mine and Mogul Mine stope waste piles.

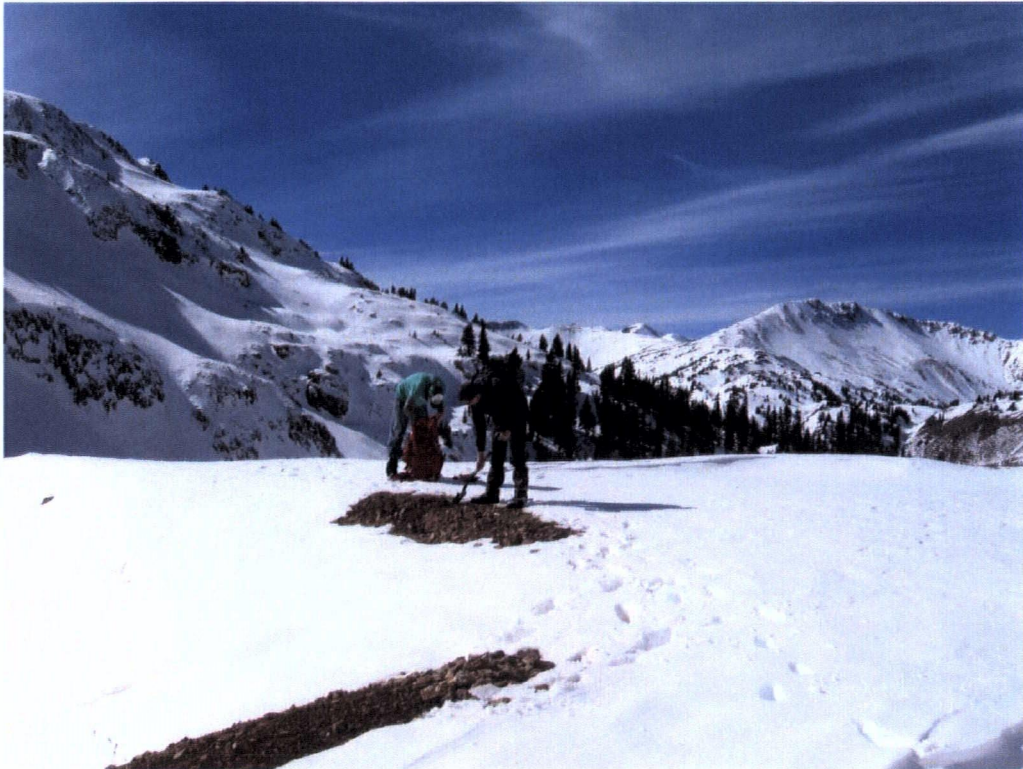
Photo 64
Grand Mogul Mine easternmost waste pile.

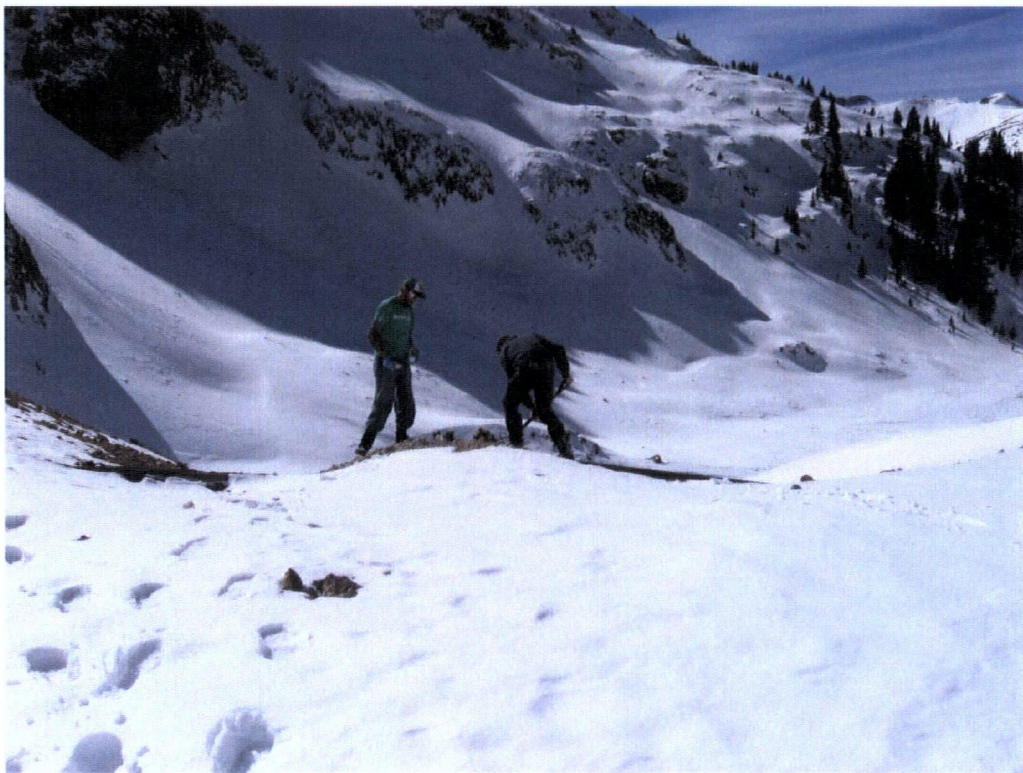
Photo 65
Collection of UASO009 (Grand Mogul Mine waste piles – east side).

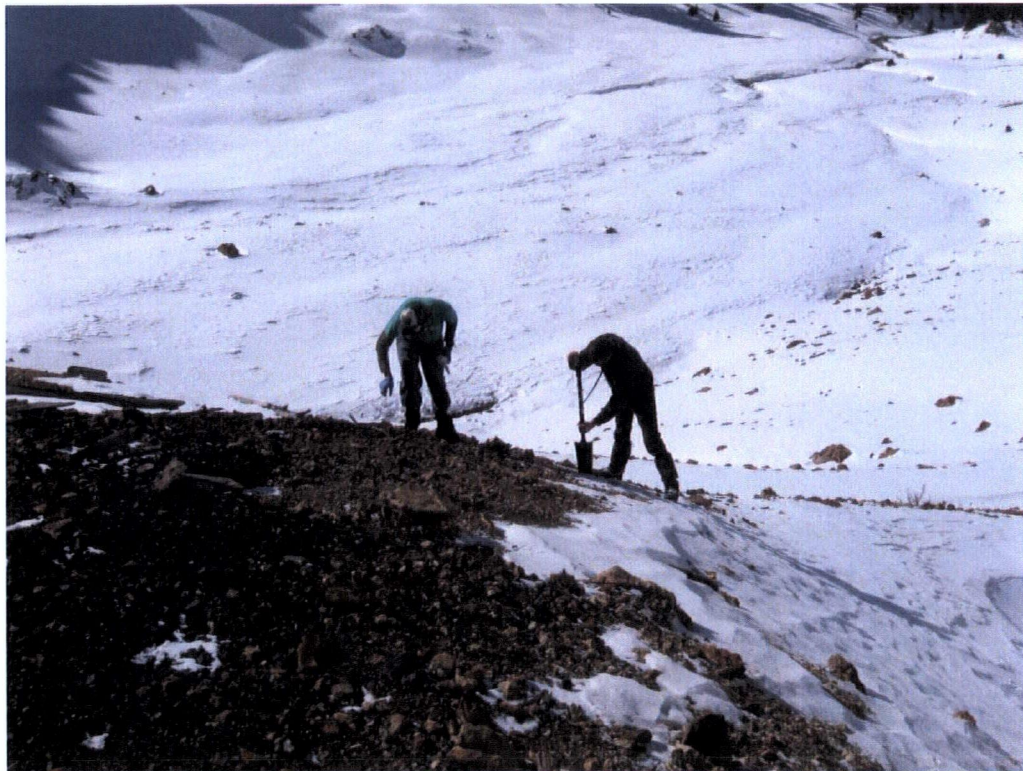
Photo 66
Collection of UASO010 (Grand Mogul Mine waste piles – center).

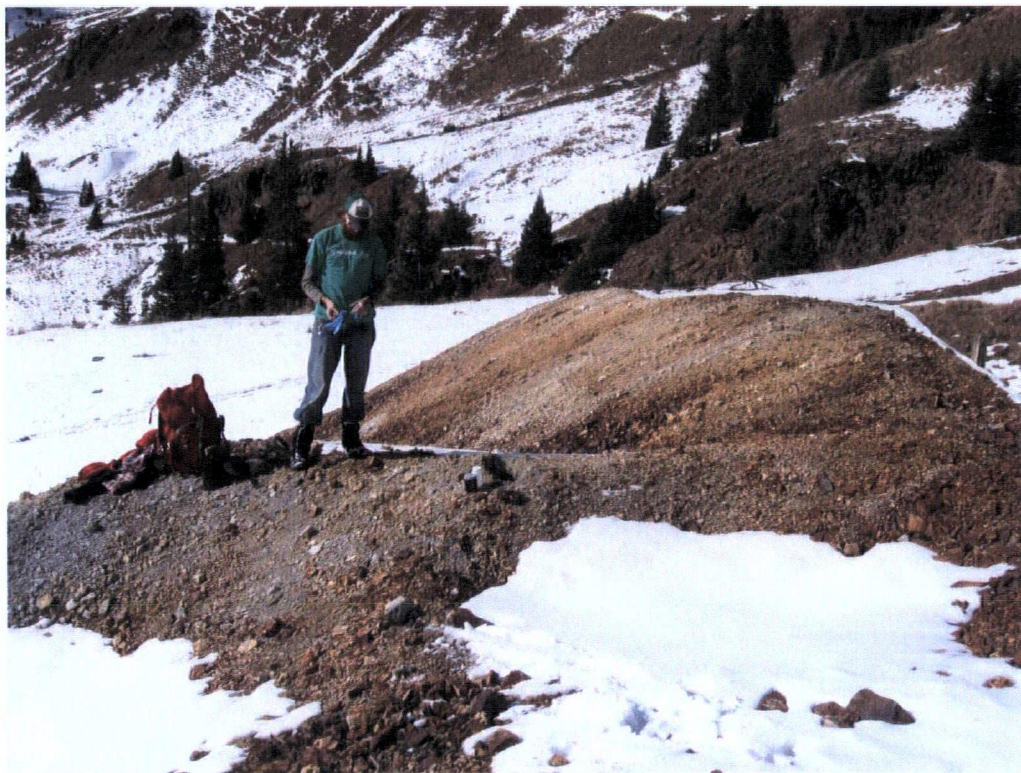
Photo 67
Collection of UASO011 (Grand Mogul Mine waste piles – west side).

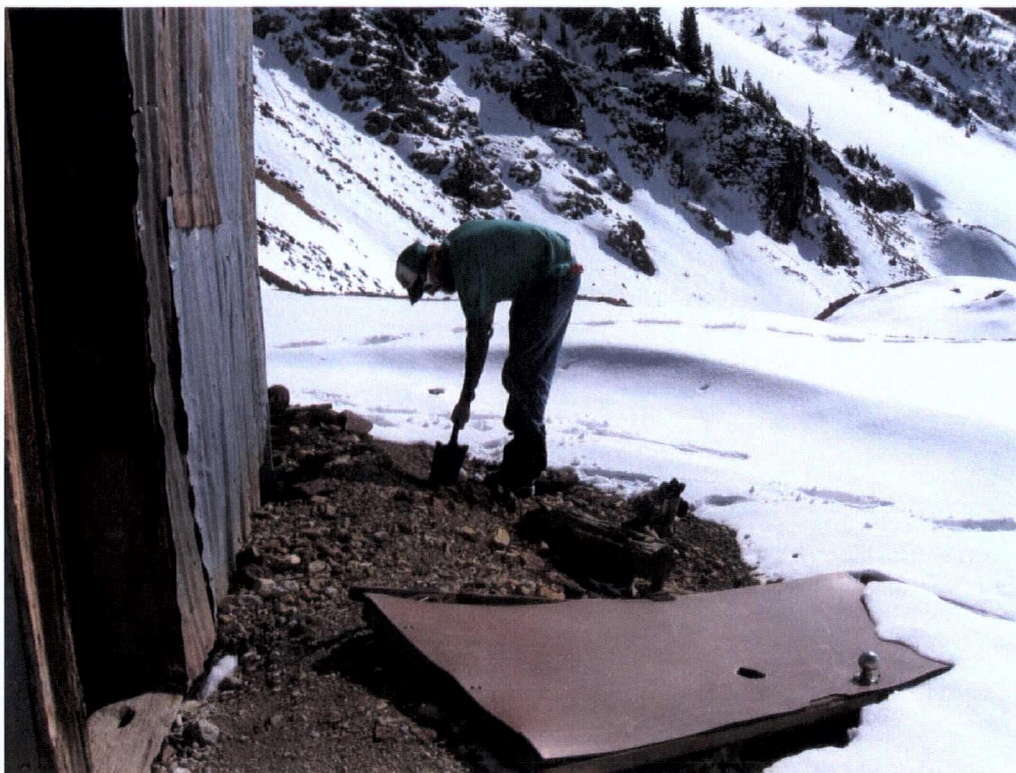
Photo 68
Collection of UASO012 (Mogul Mine waste piles – west side).

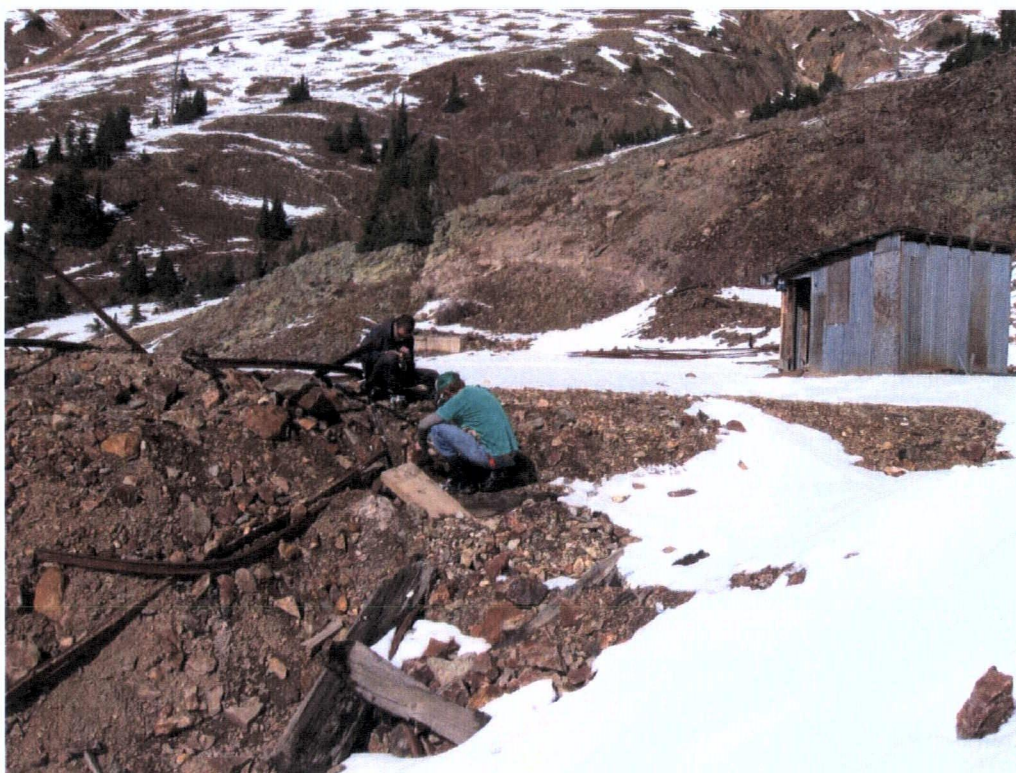
Photo 69
Collection of UASO013 (Mogul Mine waste piles – adjacent to shed).

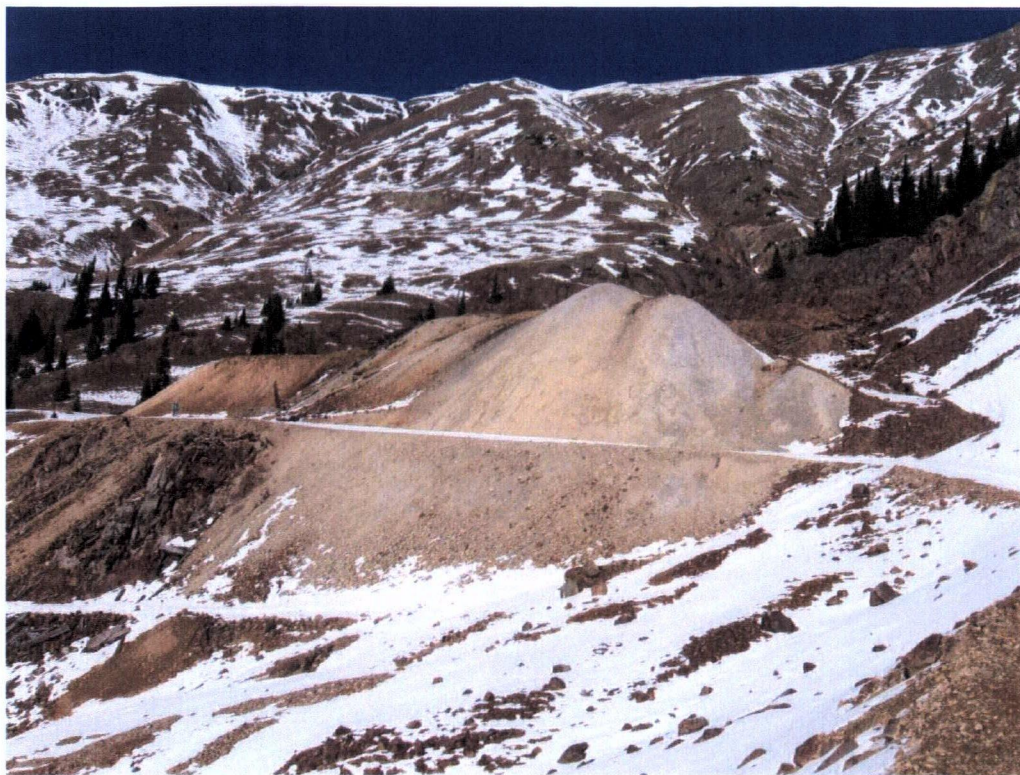
Photo 70
Collection of UASO014 (Mogul Mine waste piles – east side).
